INACTIVE AND ABANDONED MINE LANDS — Roy and Barnum- McDonnell Mines, Morton Cinnabar Mining District, Lewis County, Washington

Open File Report 2001-1
December 2001

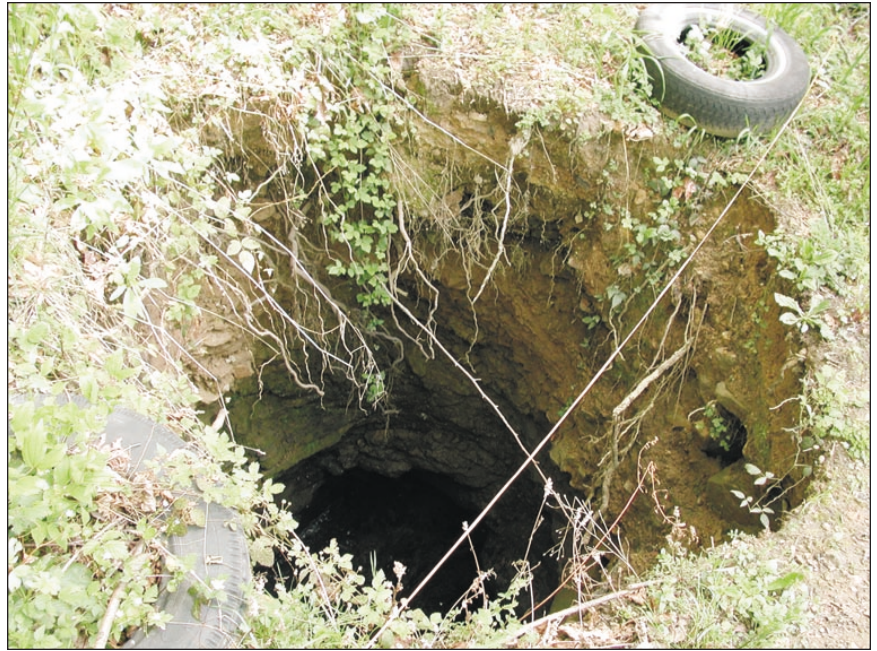
- Subsidence feature 2, a vertical opening 10 feet in diameter and approximately 26 feet deep, lies in the bed of the road approximately 30 feet north of the subsidence feature described above (Fig. 2). It lies on the centerline of Barnum-McDonnell adit 2 (Mackin, 1944).

Figure 2. Subsidence feature 2, a vertical opening 26 feet deep on Barnum-McDonnell access road.

Presence of unstable slopes, walls, waste rock, tailings, or impoundments: The hummocky ground around caved adits BM1 and BM2 and subsidence features 1 and 2 (Table 1) shows cracks and slumping (online photos 1411 and 1414). A 3-by-9-foot boulder recently rolled 30 feet between switchbacks on the road accessing this area. The “Barnum B” and “Black Wall” projected faults intersect here (Mackin, 1944, plate 1). The Roy and Barnum-McDonnell mine lands lie in both the depletion and accumulation zones of deep-seated landslides (Dragovich, 1995). A local resident attributed some caving on the site to the Feb. 28, 2001, magnitude 6.8 Nisqually earthquake. The walls of subsidence feature 2 are vertical and unsupported.

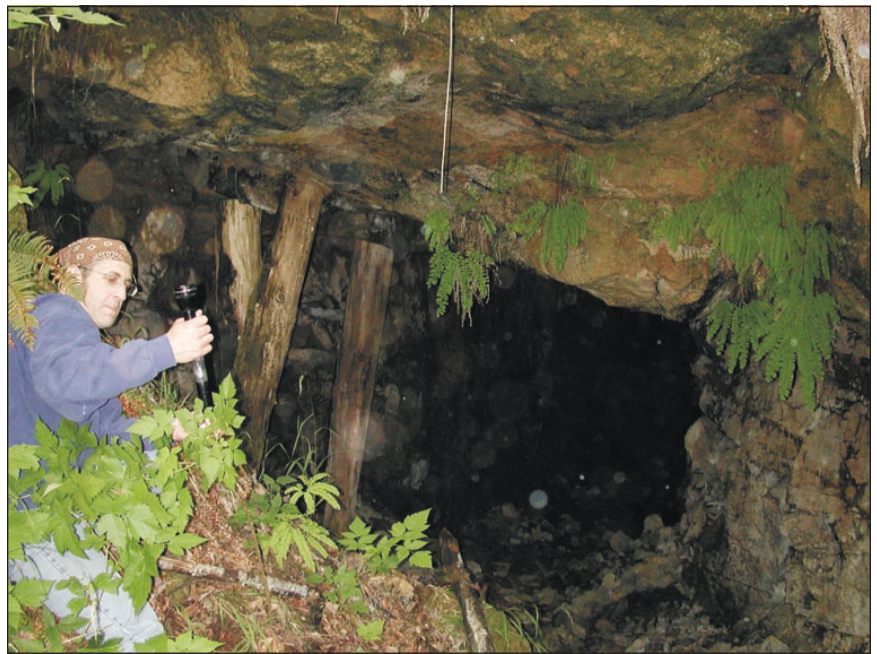
- A 10-by-12-foot open adit at 122.23153 longitude and 46.54975 latitude ($SE\frac{1}{4}SW\frac{1}{4}$ sec. 6) has a large unsupported sandstone overhang at the entrance. Slabs have calved off in the past, and timbers, which once may have provided support, appear to be deteriorated (Fig. 3). This opening dates to 1960 during leasing activity by a contractor using a front-end loader (Sidney Beck, landowner, oral commun., 2001). Its length is unknown. It lies 25 feet southeast of what appears to be the caved Parmenter adit, circa 1935 (Mackin, 1944, plate 1; online photo 1640). (Online photos may be viewed at <http://www.wa.gov/dnr/htdocs/ger/iaml/01-1/>).

Figure 3. Loren Baker at the 10-by-12-foot open adit near the Parmenter tunnel.

The overhang at the Parmenter tunnel opening presents slabs of unsupported sandstone (Fig. 3).

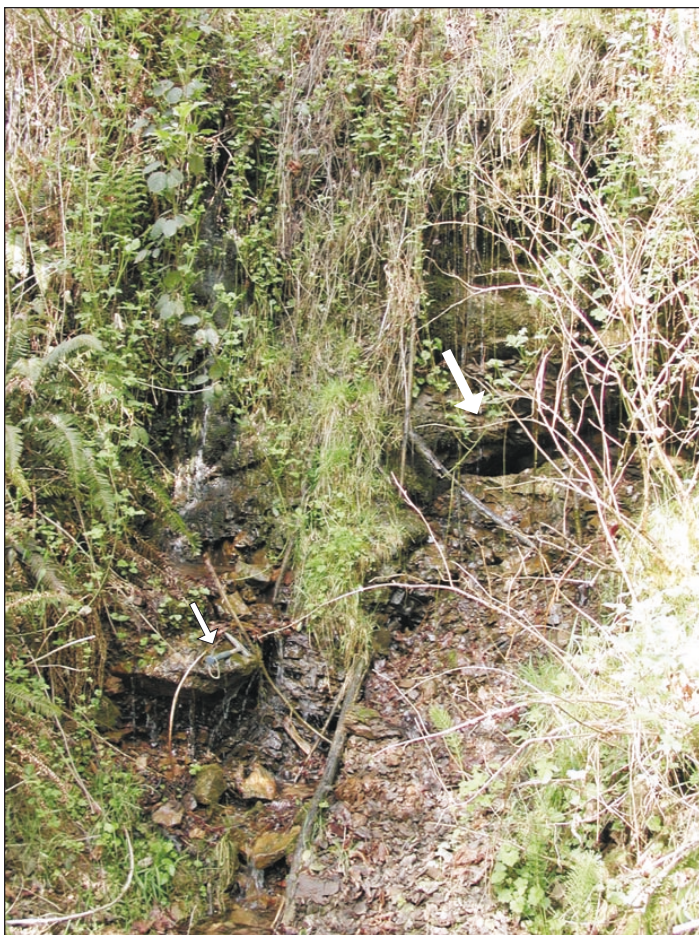
- All other mine-related openings observed have collapsed to the point of preventing entry (Fig. 4). No openings were entered during field investigations.

Figure 4. The condition of Roy adit 5 is similar to that of all other mine-related openings observed. The caved adit is indicated by the large arrow to the right. Note the hammer (small arrow to left) for scale. (See online photo 1430.)

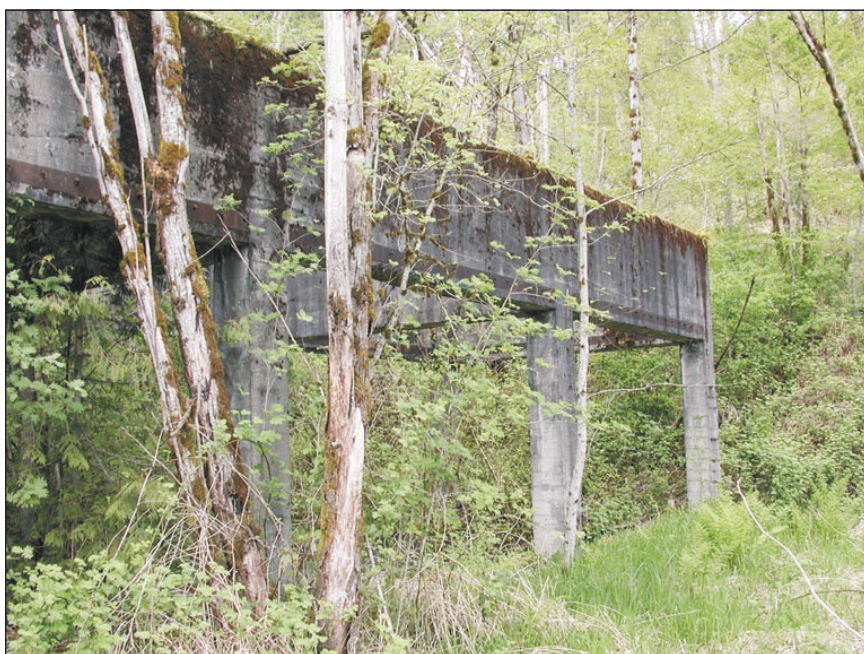
Two concrete structures are situated on the site of the circa-1940 flotation mill, 50 feet south of Davis Lake Road. The first, an above-ground structure, appears sound, but presents a hazard to anyone attempting to climb into or around it (Fig. 5), as does the second structure, a subgrade concrete sump that is partly obscured by surrounding blackberry bushes.

Figure 5. Concrete structure 1 at the mill site. (See online photos 1422, 1424, and 1426.)

Structures: The remains of the flotation mill (circa 1940) lie immediately downslope of the BM6 tunnel at an elevation of 980 feet at Davis Lake Road milepost 2. A 15-by-40-by-12-foot tall skeletal concrete structure stands on the south side of, and is visible from, the Davis Lake Road (concrete structure 1; Fig. 5; online photos 1422, 1424, 1426). This feature appears sound, but presents a hazard to anyone attempting to climb into or around it. A deteriorating 15-by-15-foot concrete foundation lies 100 feet to the northwest (concrete structure 2; online photo 1418). This structure extends 8 feet below grade, and 4-inch pipes extend into it.
